USS YORKTOWN CG-48
SEMAT II SHELL CONDITION
ASSESSMENT SURVEY
INTERIOR AREAS
12/02/01 TO 12/14/01

PREPARED BY SUPERVISOR
OF
SHIPBUILDING CONVERSION AND REPAIR
PORTSMOUTH VIRGINIA
12/13/01

14 December 2001
Serial # 1697BA-022

USS YORKTOWN (CG-48)
SHELL CONDITION ASSESSMENT SURVEY, INTERIOR AREAS.

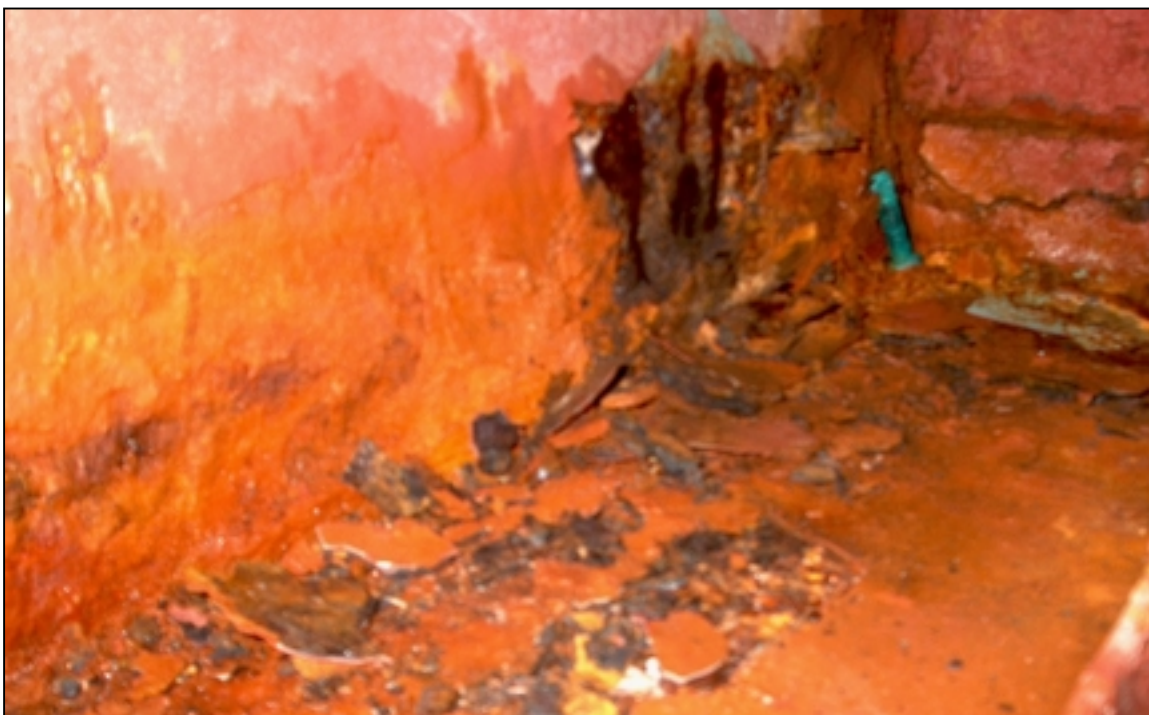
3RD STRINGER UP FROM MARGIN PLATE AT WEB FRAME (196)

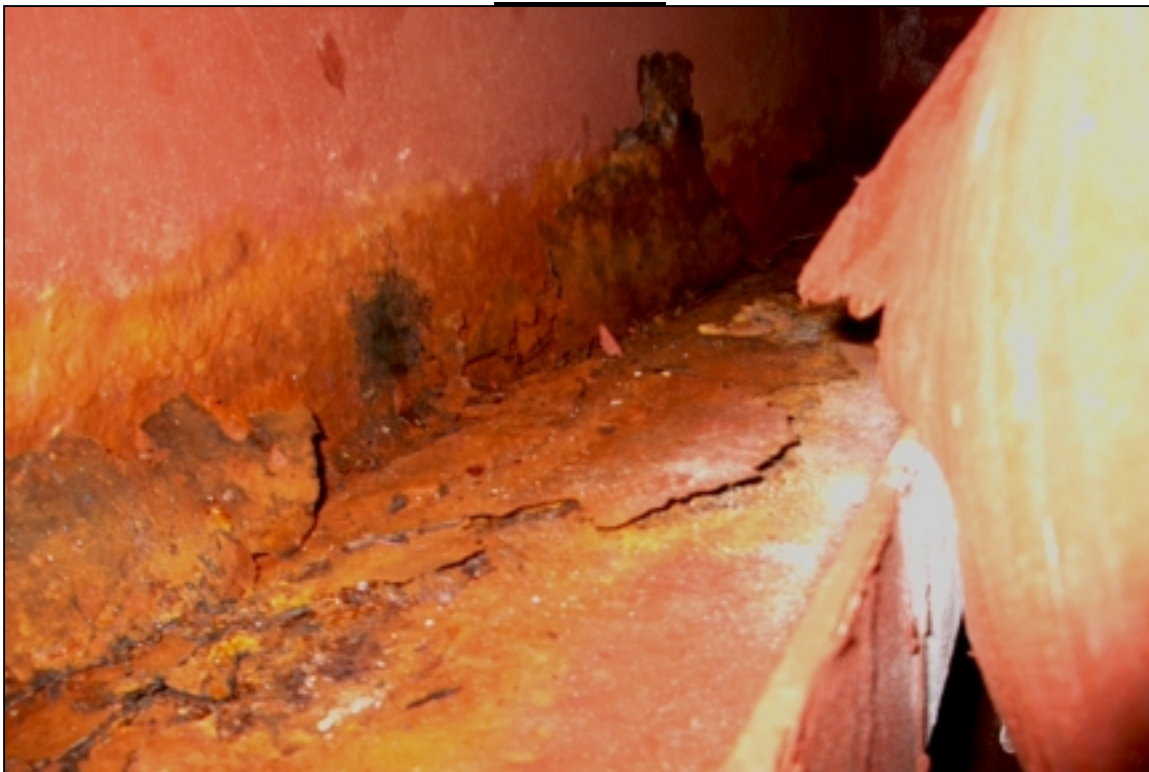
2ND STRINGER UP FROM MARGIN PLATE BETWEEN WEB FRAMES (196-204)

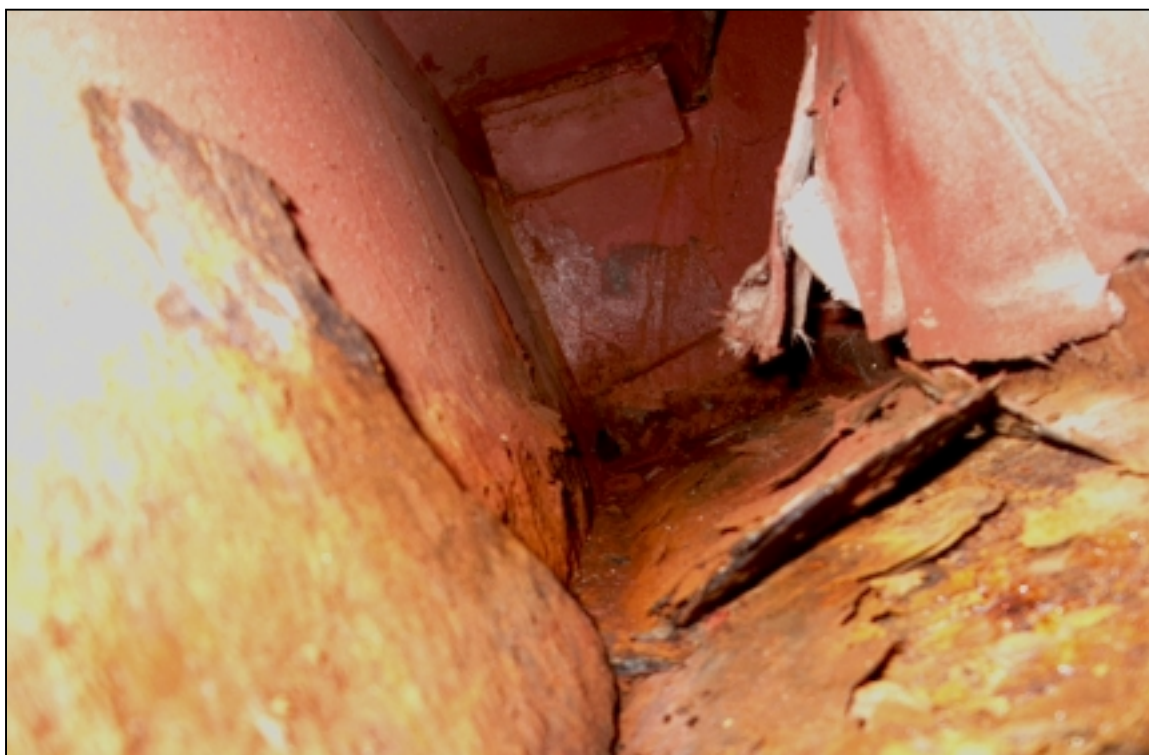
2ND STRINGER FROM MARGIN PLATE LOOKING FORWARD AT WEB FRAME (196)

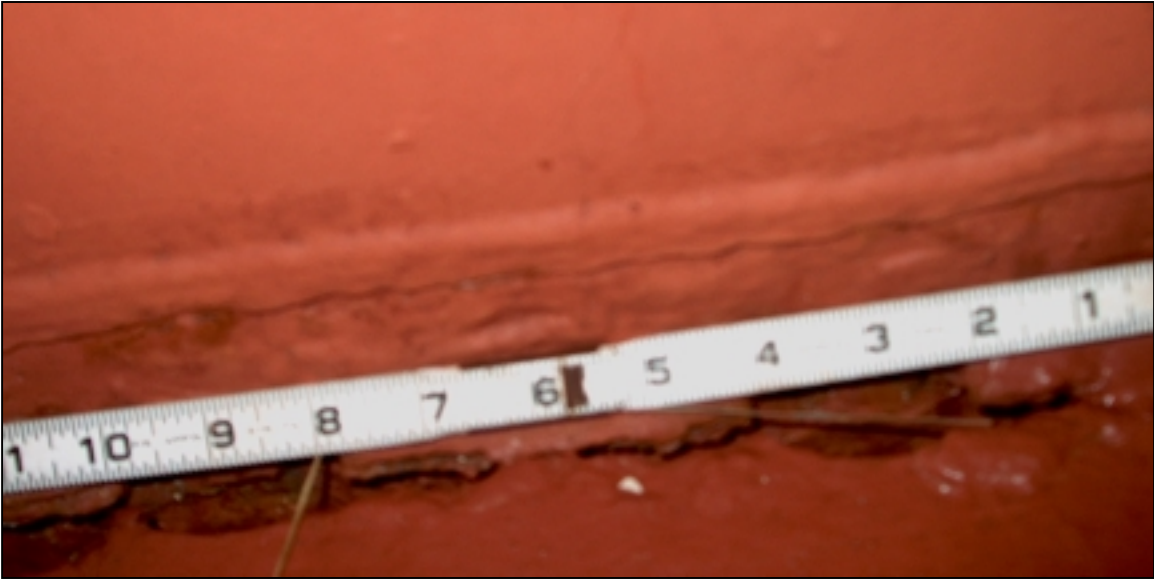
SAFETY HAZARD: 1. SERIOUS - CORRECT AS SOON AS POSSIBLE 2. SERIOUS - SUSPENSION OF EQUIPMENT/SYSTEM/SPACE REQUIRED 3. SERIOUS - WAIVER OF EQUIPMENT/SYSTEM 4. SAFETY ITEM - MINOR 5. COMBUSTIBLE MATERIAL		1. MAINTENANCE ACTION COMPLETED: PARTS DRAWN FROM SUPPLY 2. MAINTENANCE ACTION COMPLETED: REQUIRED PARTS NOT DRAWN FROM SUPPLY 3. MAINTENANCE ACTION COMPLETED: NO PARTS REQUIRED 4. CANCELLED - DEFERRAL WILL BE REMOVED FROM CSMP 5. MAINTENANCE ACTION COMPLETED: 3-M CAPABILITY UTILIZED 6. NONE OF THE ABOVE, DESCRIBE IN REMARKS/DESCRIPTION SECTION			1. MANDATORY 2. ESSENTIAL 3. HIGHLY DESIRABLE 4. DESIRABLE
DISCREPANCY DESCRIPTION: PER SEMAT II UNDERWATER HULL ASSESSMENT: FWD PUMP ROOM/SEWAGE PLANT NO.1 (5-138-0-E)					
STBD SIDE 2 ND STRINGER FROM MARGIN PLATE IS HOLED APPROX. 2FT. FWD OF WEB FRAME (146). PORT SIDE 1 ST STRINGER FROM MARGIN PLATE IS HOLED AT WEB FRAME (146) AND APPROX. 4FT AFT OF BHD (138). 2 ND STRINGER FROM MARGIN PLATE IS HOLED APPROX. 4FT AFT OF BHD (138) AND AT WEB FRAME (146)

2ND STRINGER FROM MARGIN PLATE AT WEB FRAME (146)
IS HOLED.

RECOMMENDED REPAIRS: RECOMMEND REPAIR ACTIVITY CUTOUT APPROX. 8LF OF 1 ST & 2 ND STRINGERS PORT SIDE 16LF TOTAL AND 8LF OF 2 ND STRINGER STBD SIDE. REPLACE WITH 10X4X11.55 T-BEAM 24 LF TOTAL PRIME AND PAINT AREAS DISTURBED BY REMOVALS INSIDE AND .OUTSIDE OF HULL. REPAIRS TO BE ACCOMPLISHED DURING DRYDOCK AVAILABILITY.					
SSPORT C221 POC: B. WILLIAMS (757) 396-4001 EXT 2166, TPOC: M. MELVIN (757) 396-4001 EXT 2128					
CSMP SUMMARY: 1 ST & 2 ND STRINGERS PORT SIDE & 2 ND STRINGER STARBOARD SIDE ARE HOLED				TEST# MRC 1102/1	
ROOT CAUSE/AMPLIFICATION: H1				STEP# 1,2,3,4 & 5	
SYSTEM LEVEL IMPACT:					
PART NO.	NOMENCLATURE		QTY	NSN	COST
1					
2					
3					
4					
5					
6					
FIRST CONTACT BAILEY		RATE DC1	SECOND CONTACT WATSON		RATE HT1
ASSESSOR / ACT / TECH ID# J. LaROCK/ T. ILGENFRITZ		QED SYSTEMS INC.		TD	LOGISTICIAN
				TL	TSP

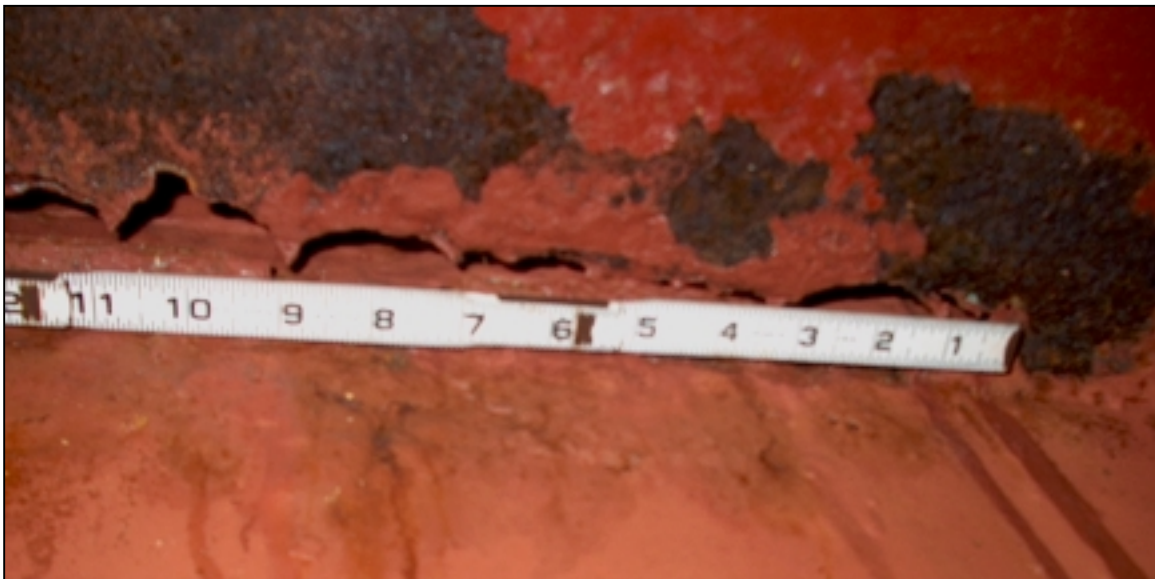
2ND STRINGER FROM MARGIN PLATE VIEW FROM BELOW

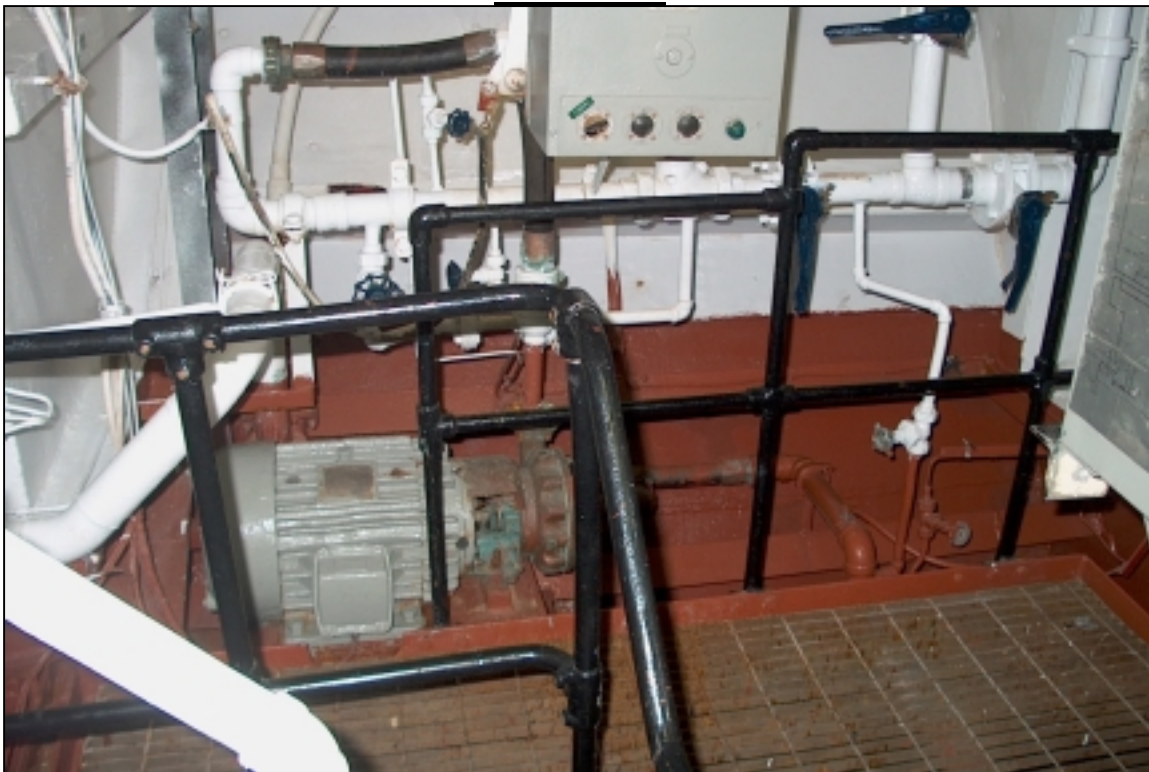
CORRODED STRINGERS FOUND IN THIS AREA

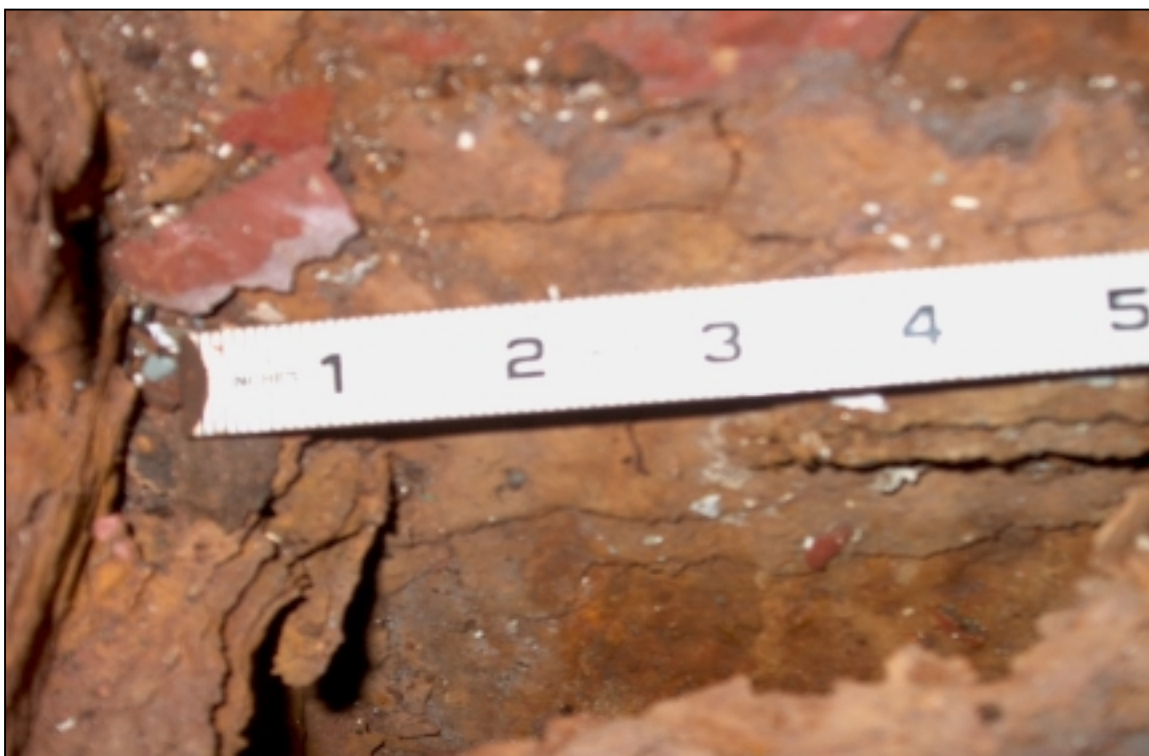
1ST STRINGER FROM MARGIN PLATE AT WEB FRAME (146) IS HOLED

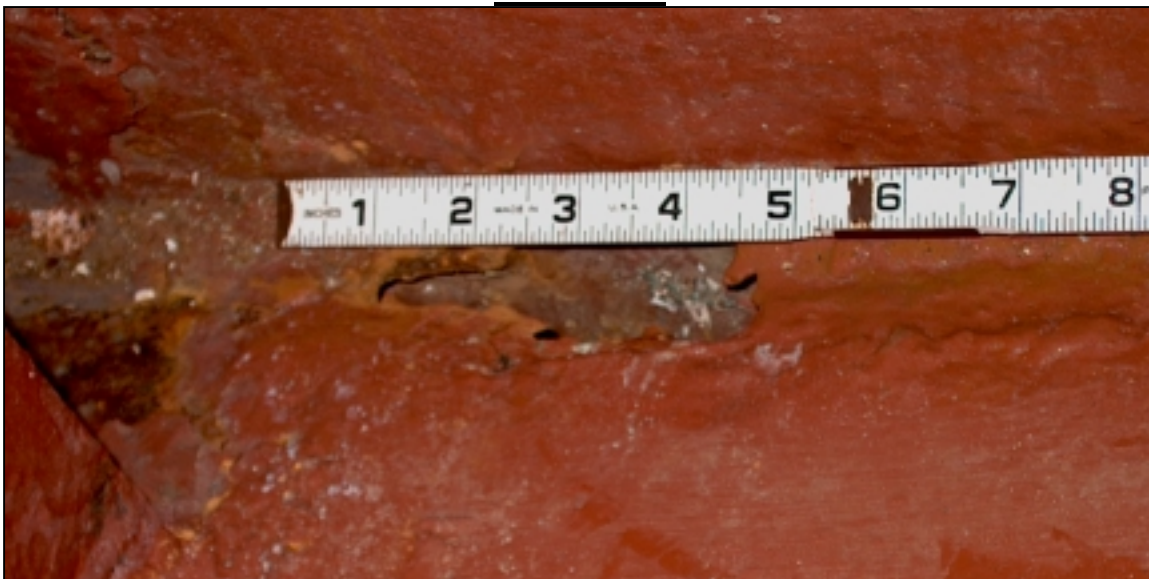
1ST STRINGER FROM MARGIN PLATE APPROXIMATELY 4 FT AFT OF BHD (138)

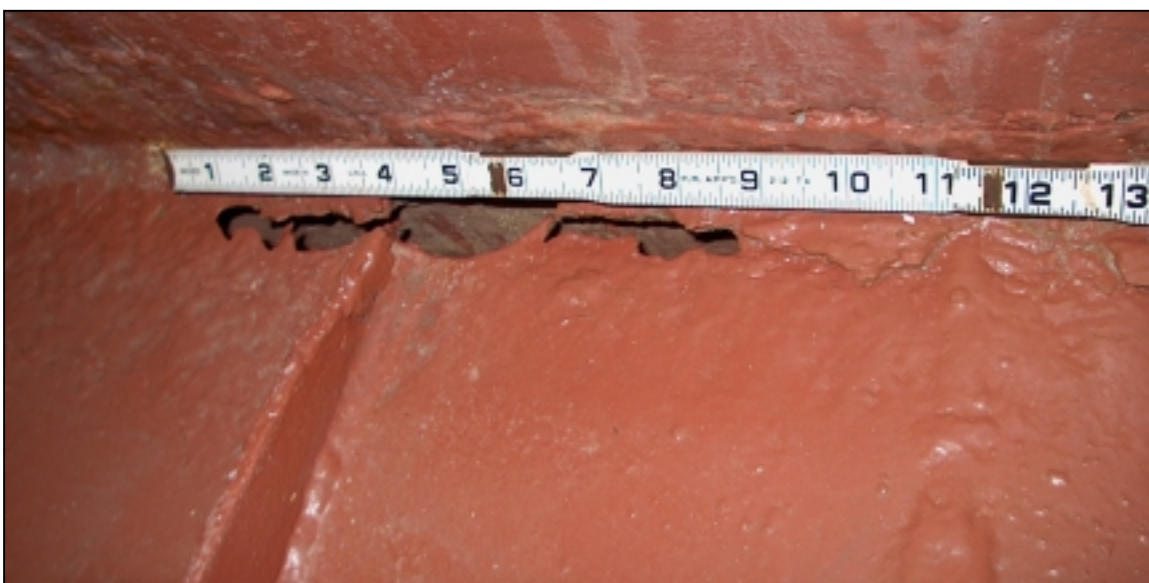
2ND STRINGER FROM MARGIN PLATE APPROXIMATELY 4 FT AFT OF BHD (138)

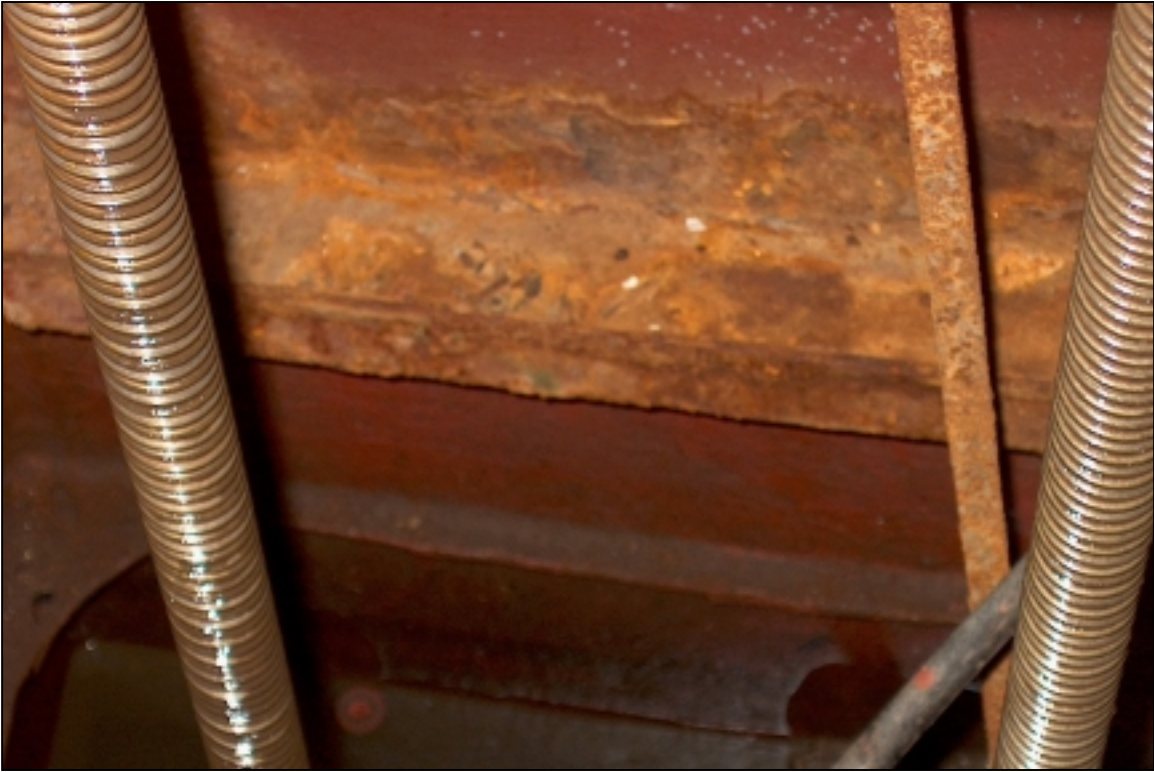
PIT SWORD AREA CORROSION ON INBOARD SIDE OF F/O TANK (6-138-2-F)

PAINT SEPARATION ON F/O TANK (6-138-1-F) AND APPROX.20 SF OFRUST &PAINT SEPARATION IN PIT SWORD AREA.					
RECOMMENDED REPAIRS:RECOMMEND SHIPS FORCE CLEAN PORT &STBD BILGE POCKETS ,TANK TOP(6-138-1-F) AND PIT SWORD AREA					
TO BARE METAL,PRIME AND PAINT APPROX.128 SF TOTAL.					
SSPORT C221 POC: B. WILLIAMS (757) 396-4001 EXT 2166, TPOC: M. MELVIN (757) 396-4001 EXT 2128					
CSMP SUMMARY:CORROSION IN PORT&STBD BILGE POCKETS,ON F/O TANK TOP (6-138-1-F) AND PIT SWORD AREA.				TEST# MRC 1102/1	
ROOT CAUSE/AMPLIFICATION: H1				STEP# 1,2,3,4 & 5	
SYSTEM LEVEL IMPACT:					
PART NO.	NOMEMCLATURE		QTY	NSN	COST
1					
2					
3					
4					
5					
6					
FIRST CONTACT BAILEY	RATE DC1	SECOND CONTACT WATSON	RATE HT1	PHONE	
ASSESSOR / ACT / TECH ID# J. LaROCK/ T. ILGENFRITZ QED SYSTEMS INC.			TD	TL	LOGISTICIAN
					TSP

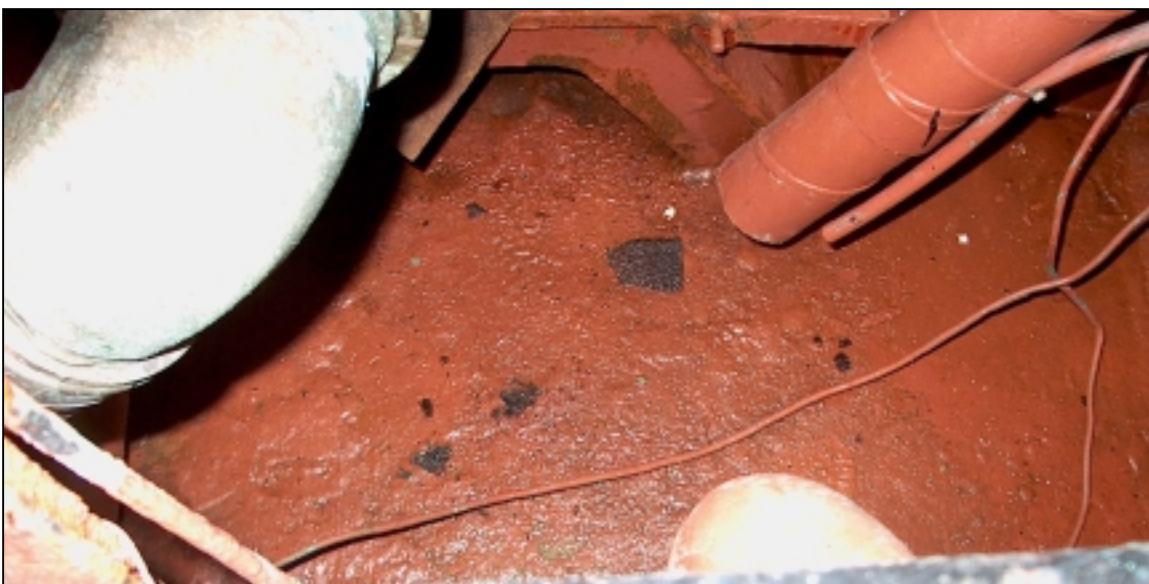
PAINT FAILURE ON TOP OF F/O TANK (6-138-1-F)

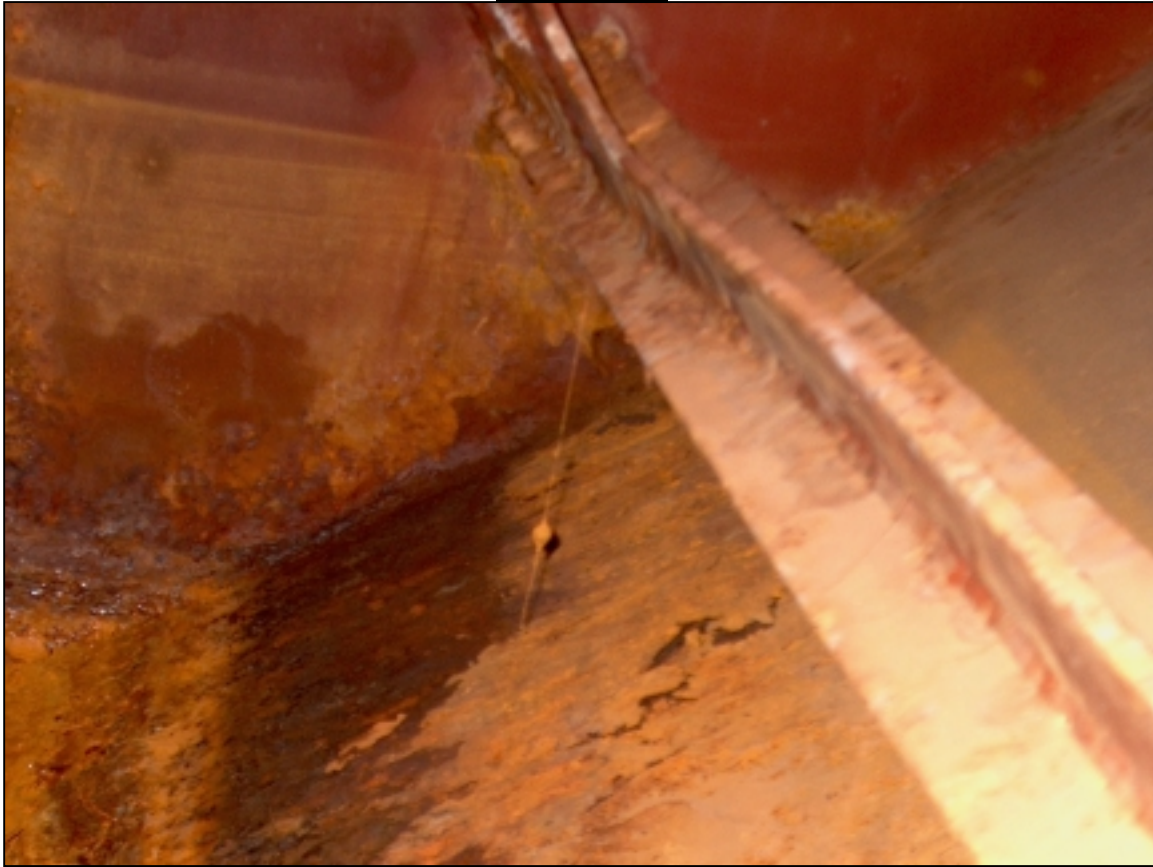
CORROSION ON SHELL PLATE UNDERNEATH SEWAGE HOLDING TANK 4 ½ -146-2-W

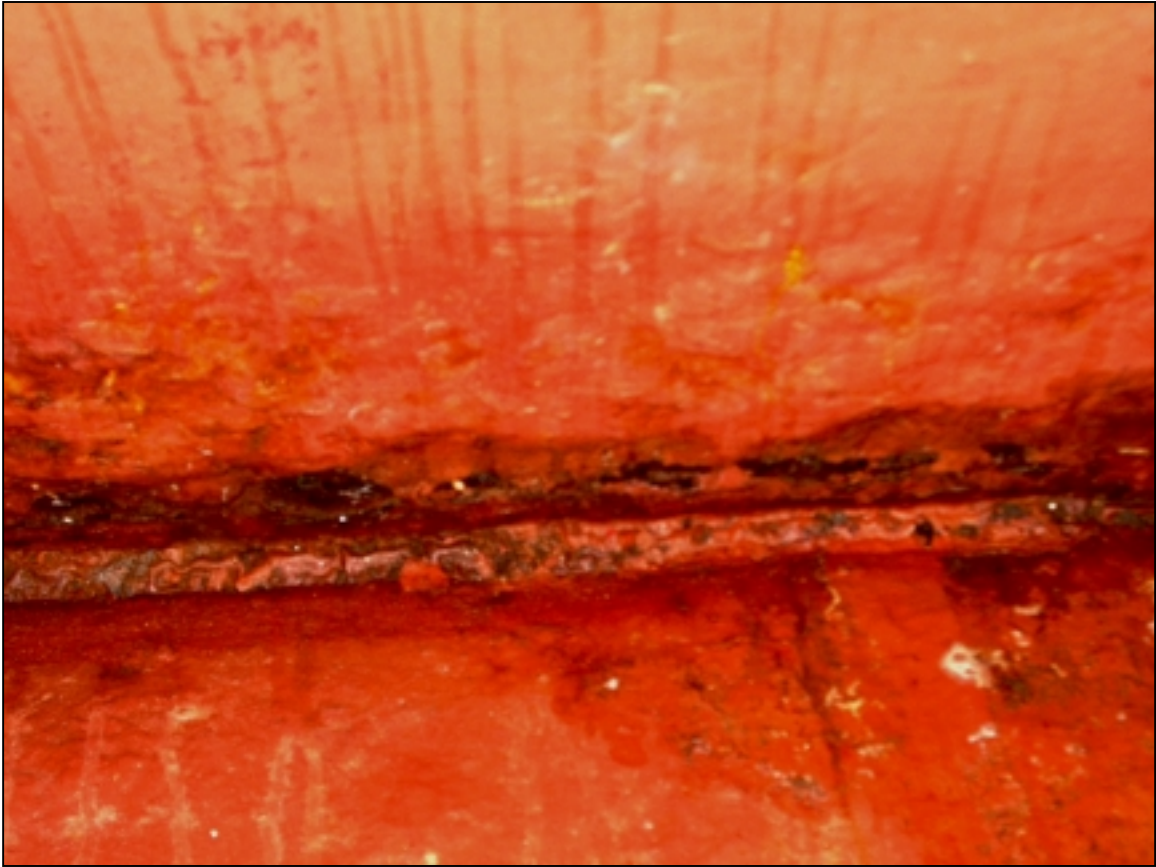
TYPICAL VIEW OF BILGE POCKET, HEAVY PAINT SEPARATION AND CORROSION.

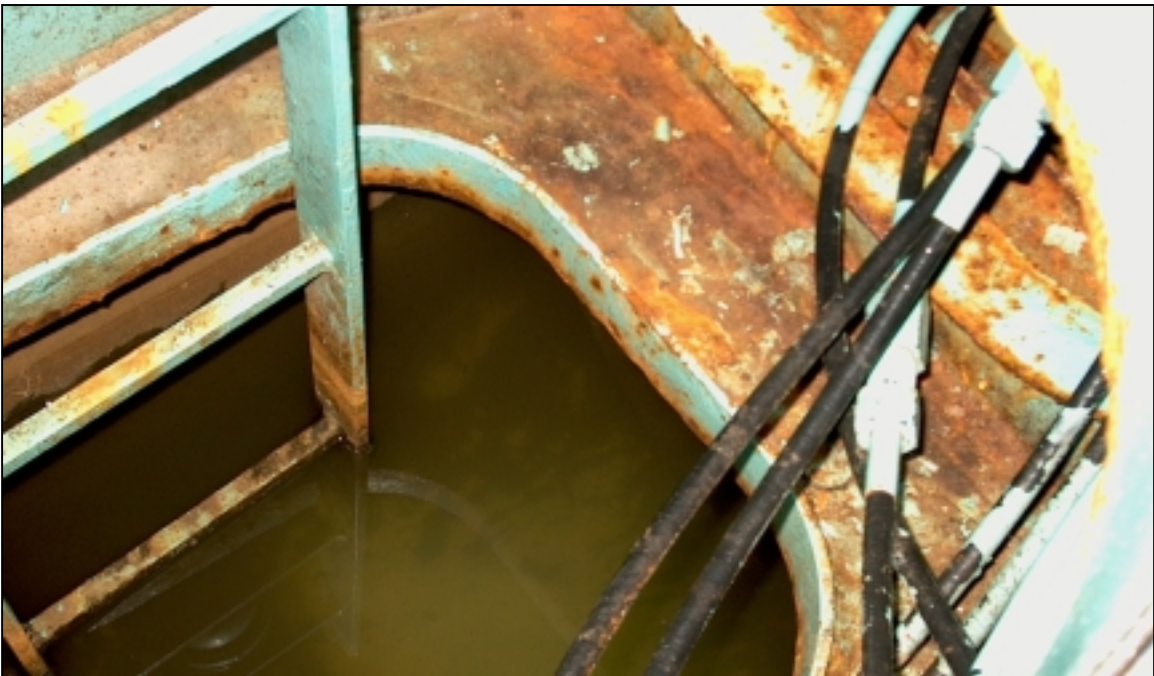
CSMP SUMMARY: APPROXIMATELY 30 SF OF SURFACE RUST IN EDUCTOR ROOM								TEST# MRC 1102/1		
ROOT CAUSE/AMPLIFICATION: H1								STEP# 1,2,3,4 & 5		
SYSTEM LEVEL IMPACT:										
PART NO.		NOMEMCLATURE				QTY	NSN		COST	
1										
2										
3										
4										
5										
6										
FIRST CONTACT BAILEY		RATE DC1		SECOND CONTACT WATSON			RATE HT1		PHONE	
ASSESSOR / ACT / TECH ID# J. LaROCK/ T. ILGENFRITZ QED SYSTEMS INC.					TD	TL		LOGISTICIAN		TSP

SURFACE RUST IN EDUCTOR ROOM

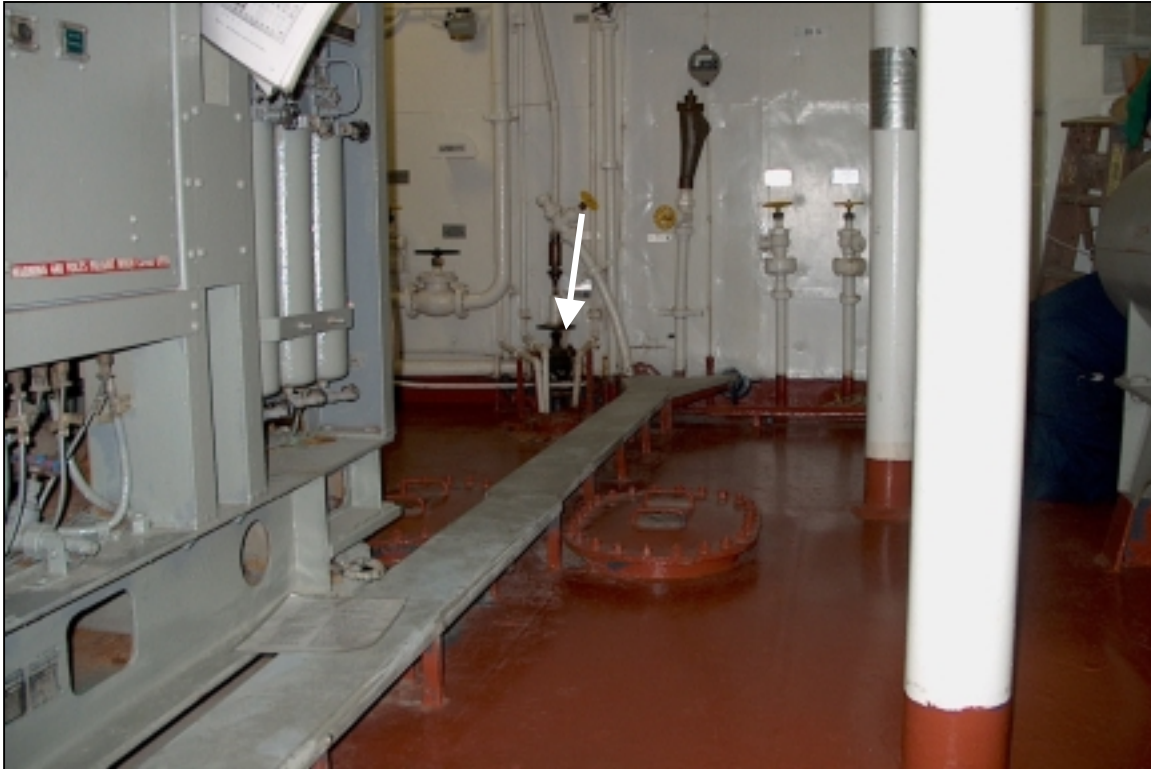
CORROSION AND LOW U/T READINGS WERE FOUND UNDER SONAR COOLING SKID (HD-1074). ARROW INDICATES EDUCTOR PIT WHERE LOW U/T READINGS WERE ALSO TAKEN. SEE DRAWING. (CSMP JSN-2409)

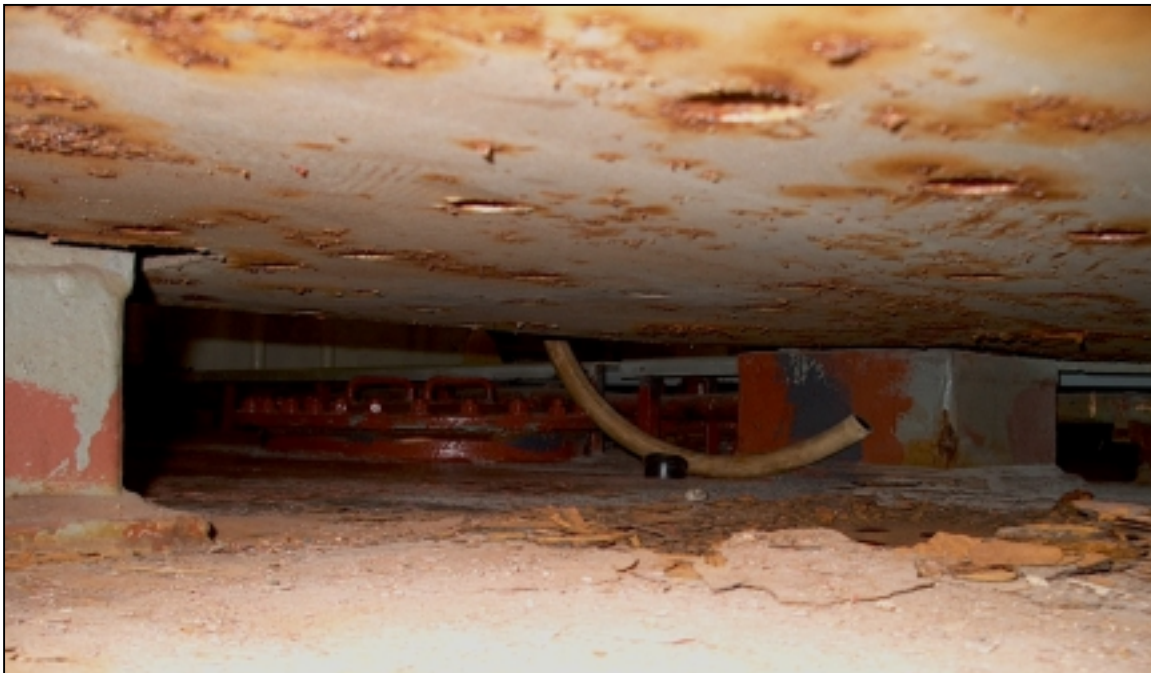
TANK TOP (DEWATERING VOID 6-58-1-V) UNDERNEATH SONAR COOLING SKID

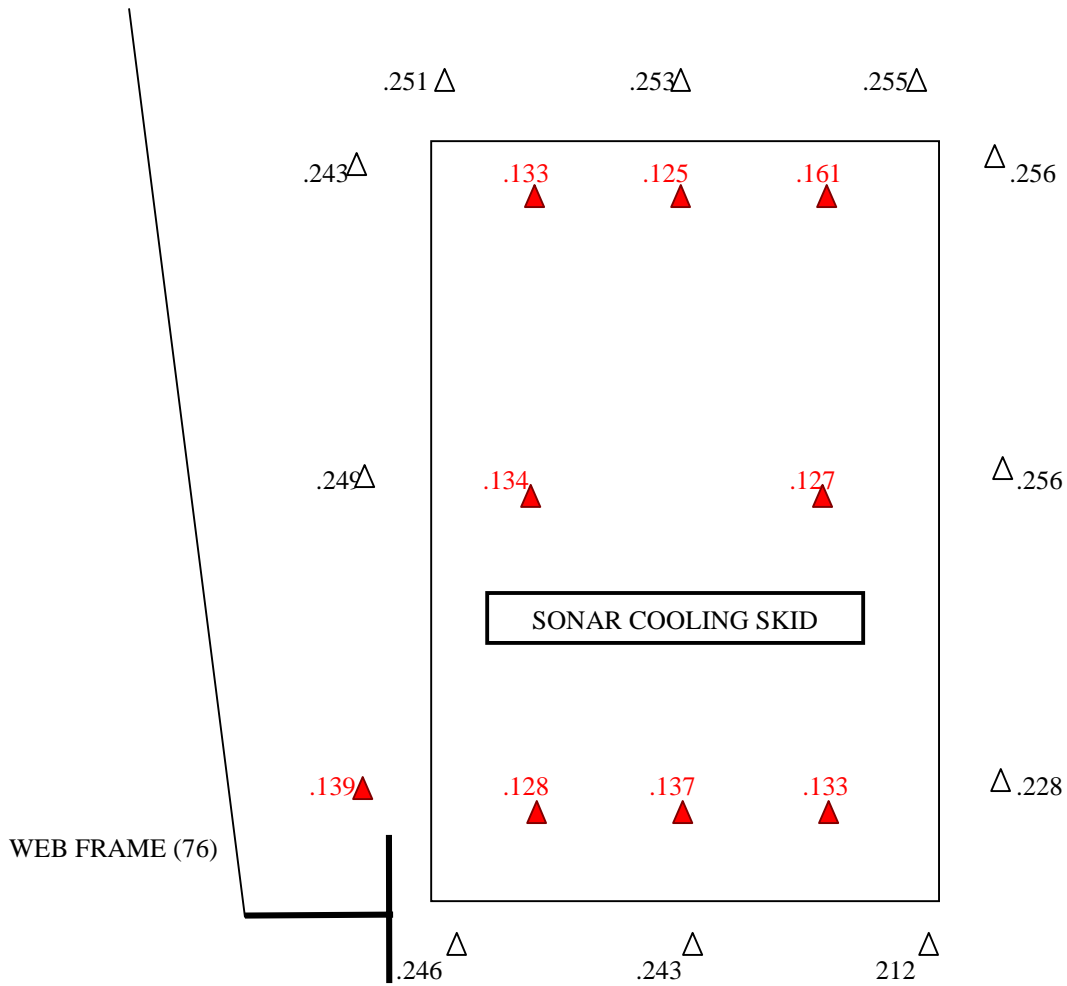
TANK TOP / DECK
 DESIGN THICKNESS .250
 MINIMUM .187

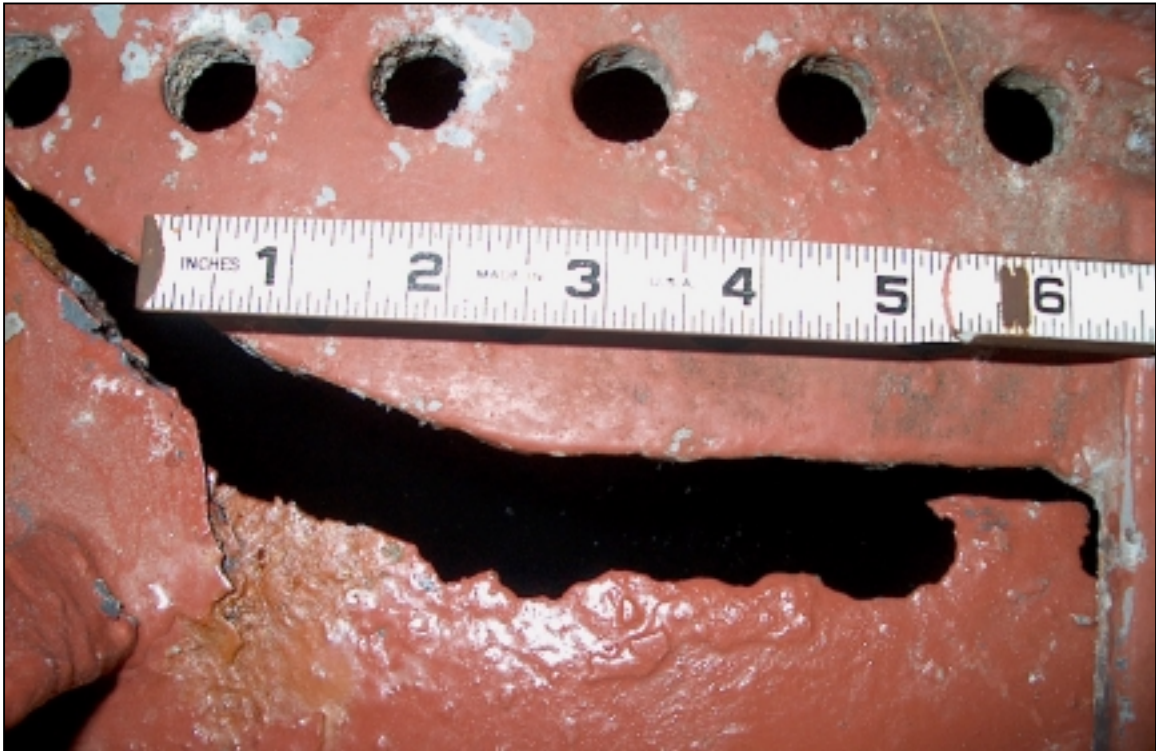
HEAVY DETERIORATION AROUND EDUCTOR OPENING LOW U/T READINGS WERE
RECORDED IN THIS AREA. (CSMP / JSN-2409)

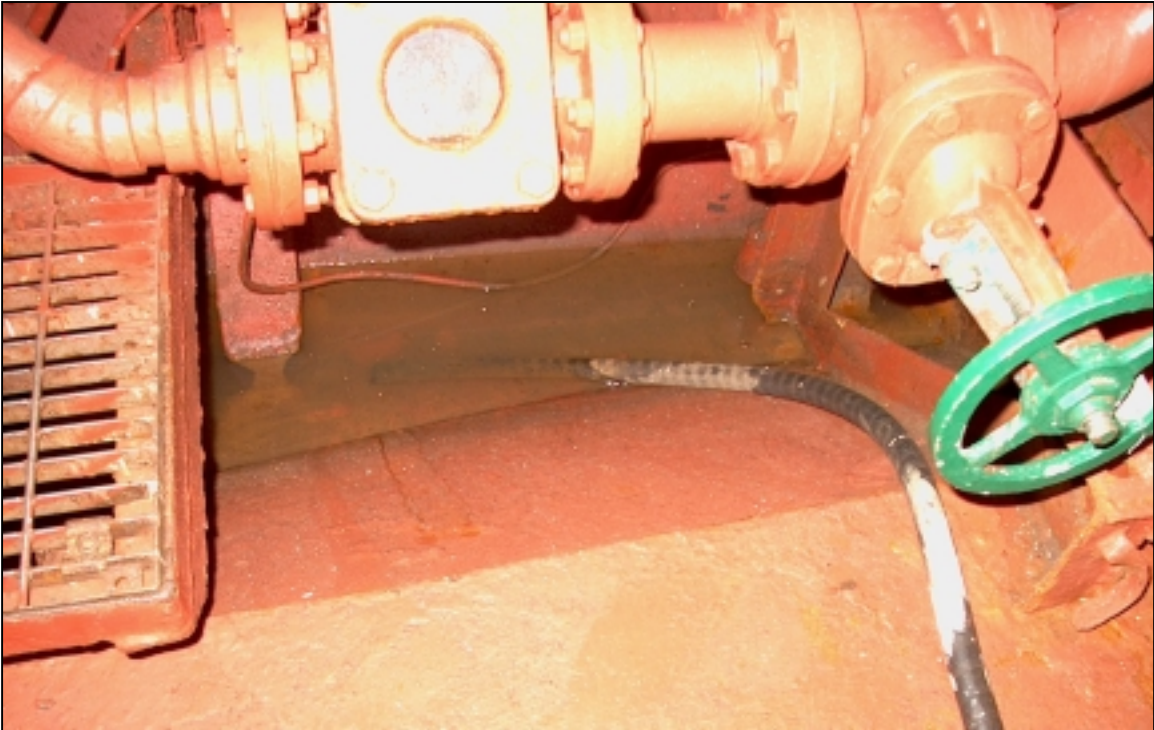
BILGE POCKET BETWEEN BHD (426) AND WEB FRAME (434)

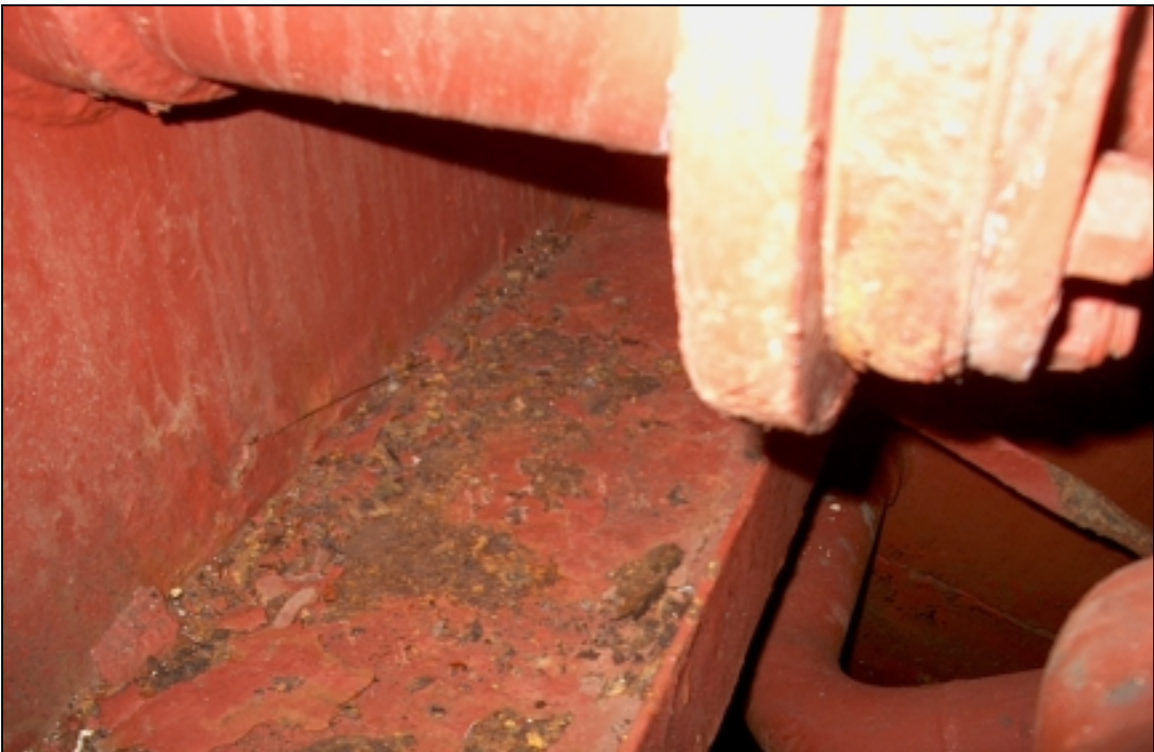
1ST STRINGER FROM MARGIN PLATE AT WEB FRAME (434)
